## «BF Utnefjord» VARD LANGSTEN

*Surface preparation and application report car deck area  
(application of Jotacote UNI N10 ALRT & Jota Armour 7035).*

**VISIT REPORT Maintenance and repair.**

<b>Ship</b> BF” UTNEFJORD”	<b>Shipyard:</b> VARD LANGSTEN	<b>Report No:</b> 01.	
<b>Owner:</b> Boreal Sjø	<b>Location:</b> Tomrefjord	<b>Page 1 of 7</b>	
<b>Area:</b> Car deck #56-0	<b>Contractor:</b> North Side A/S	<b>Date:</b> 21.05-25.05.22	
<b>Stage at time of visit:</b> Surface preparation/cleaning inspection		<b>Application:</b> Airless spray.	
<b>Product Name:</b>	<b>Coat No.:</b>	<b>Colour</b>	<b>D.F.T.</b>
Jotacote UNI N10	1	AL	200 microns
Jota Armour WG	2	Grey Ral 7035	1000 microns.
<b>NAME:</b>		<b>COMPANY:</b>	
Bjarte Bakken		VARD LANGSTEN AS	
Steinar Fitjar (Surface prep only).		Boreal Sjø A/S	
Mareno Ernes		JOTUN AS	
<b>REMARKS:</b>			
<p><u>Surface preparation</u>  <b>16.05.22 #56-#-56</b> High pressure water washing with detergent and steam water cleaning accepted to start further preparation.  <b>21.05.22 #56-#0</b>            Blast cleaning with airless blast cleaner machine to standard Sa 2,5 ISO 8501-1 are accepted except from:</p> <ul style="list-style-type: none"> <li

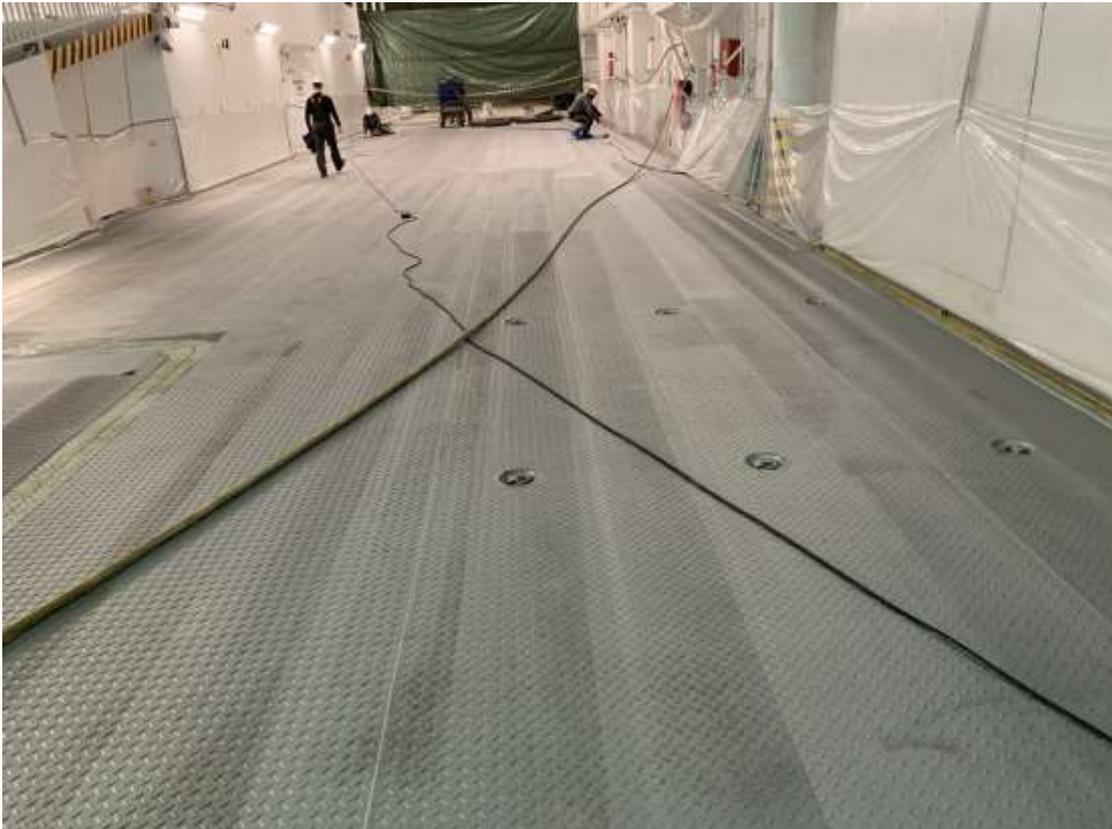
Generally picture of car deck after blast cleaning.

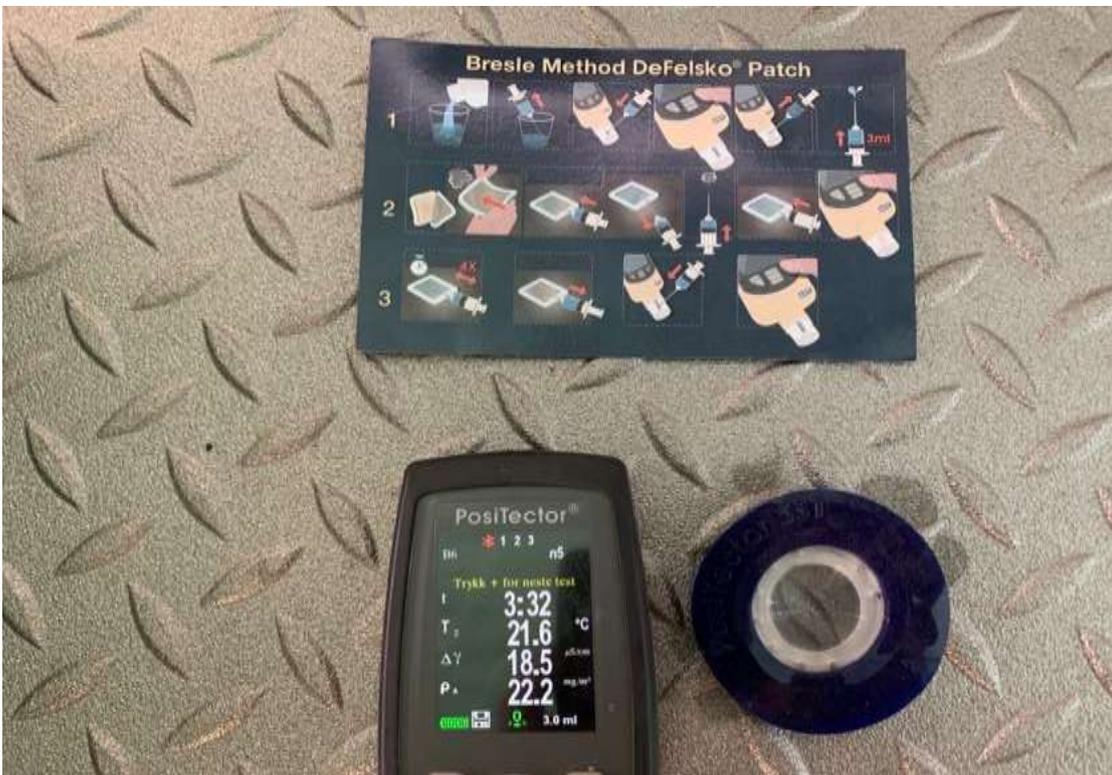
Bresle test results accepted 22,2mg/m<sup>2</sup>

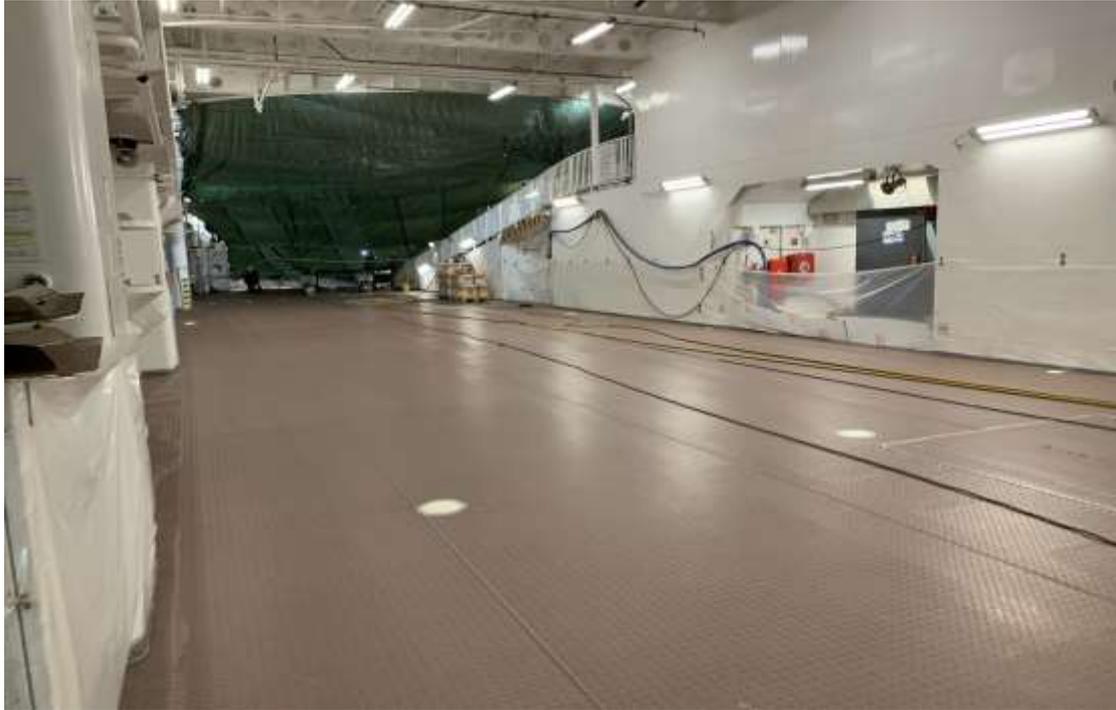
Generally picture after application Jotacote UNI N10 ALRT

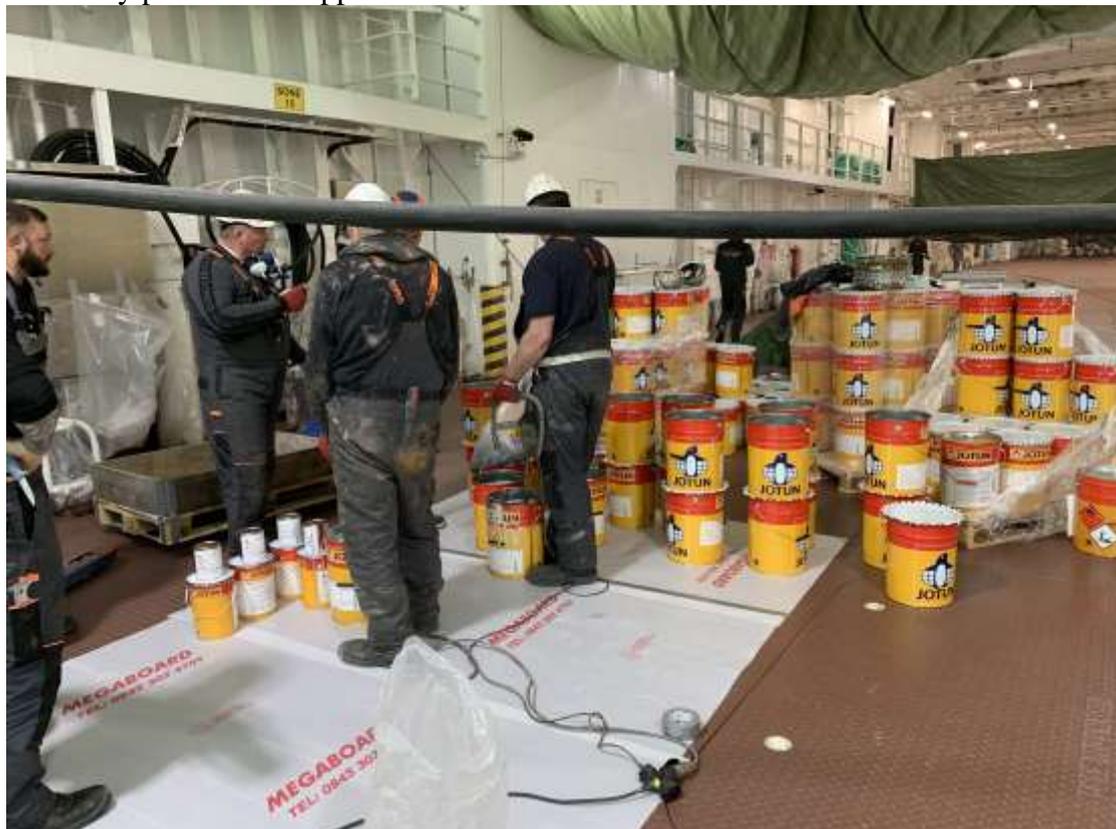
Jota Armour ready to be applied.

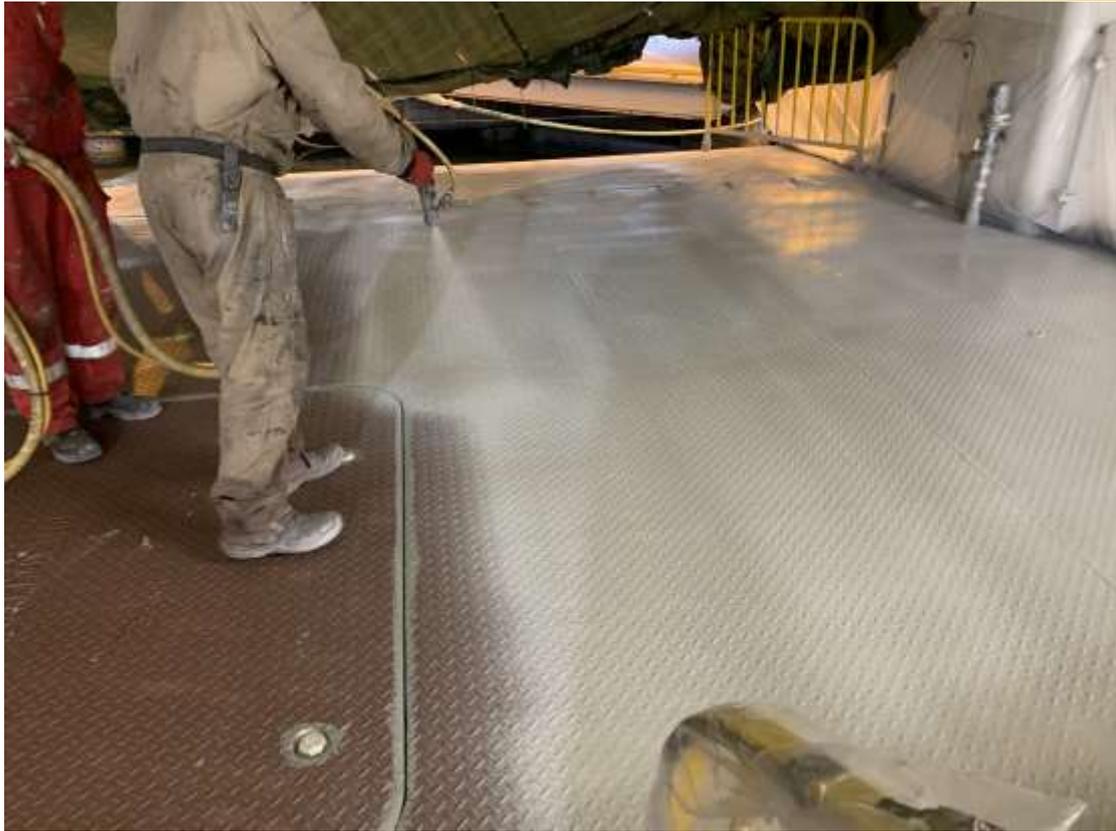
Application of Jota Armour.

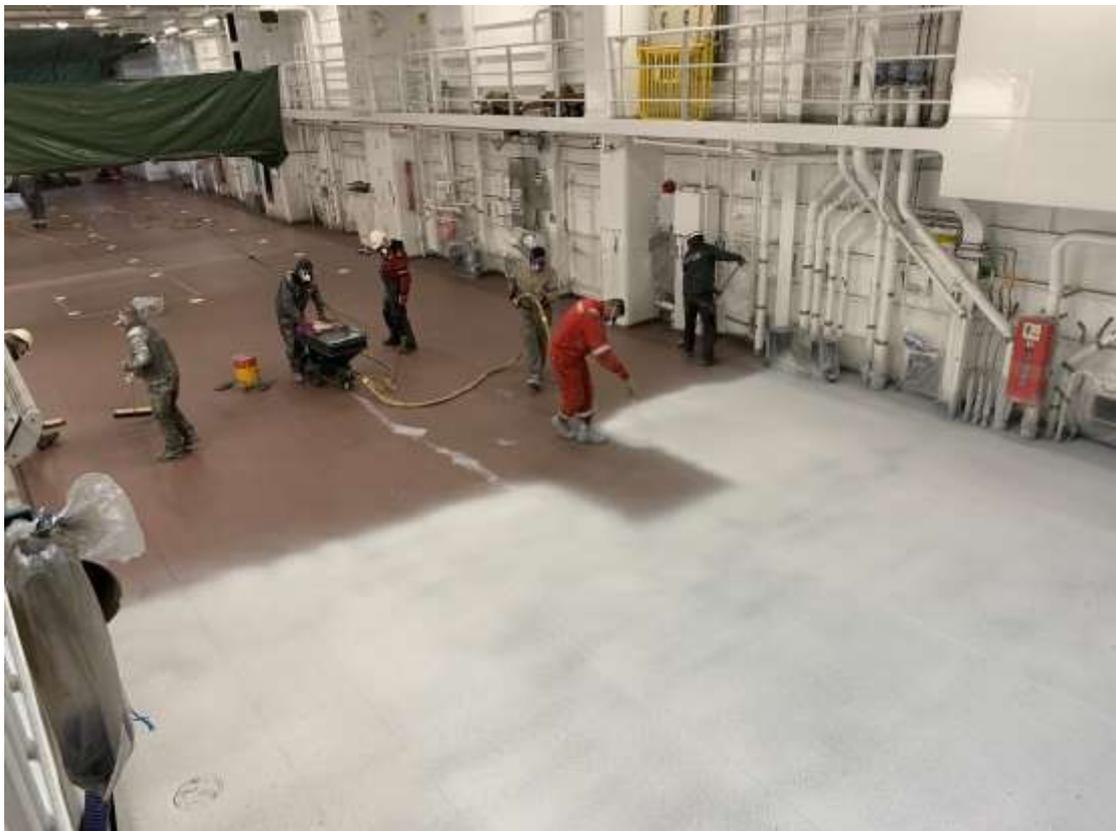
Application of Jota Armour.

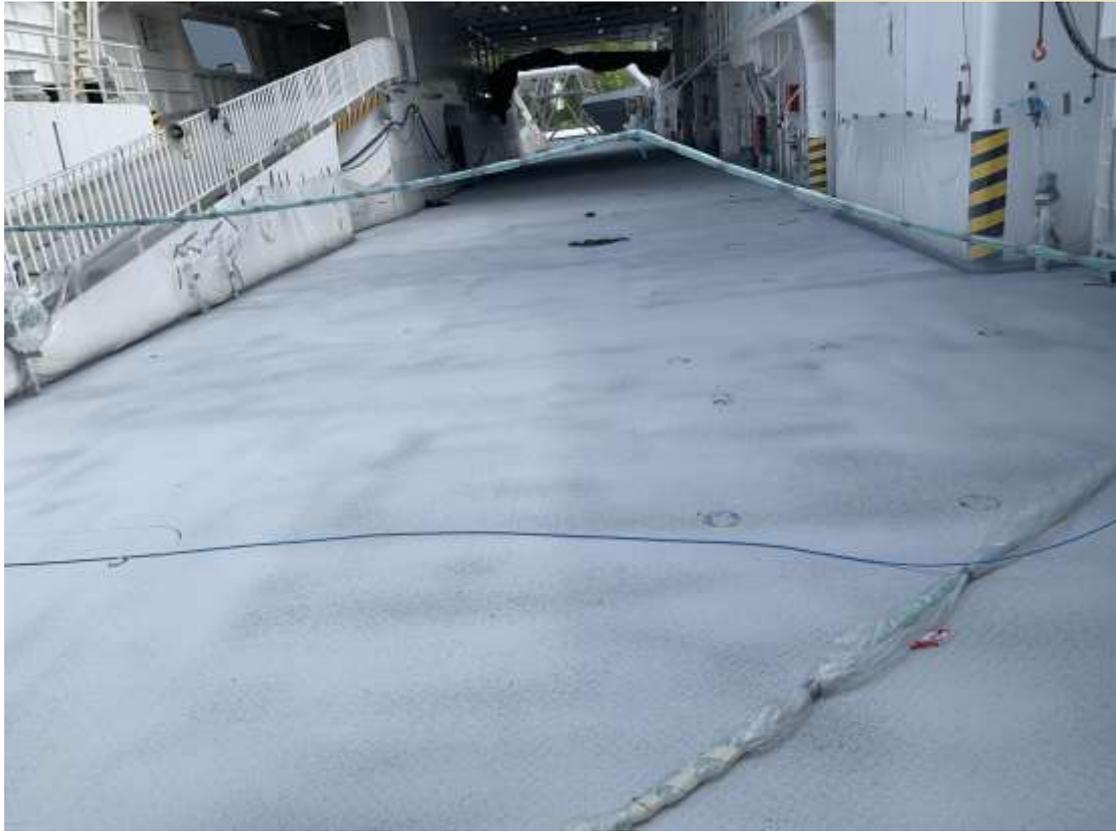
Application of Jota Armour completed.

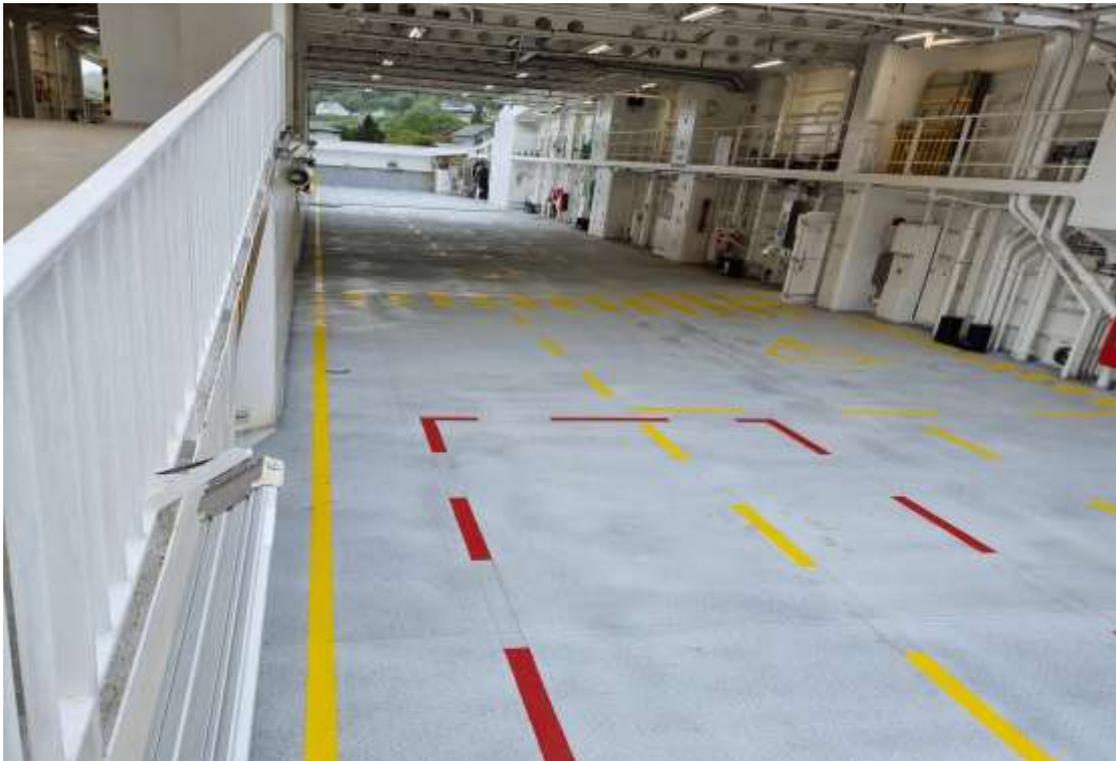
Marking of deck area finished.

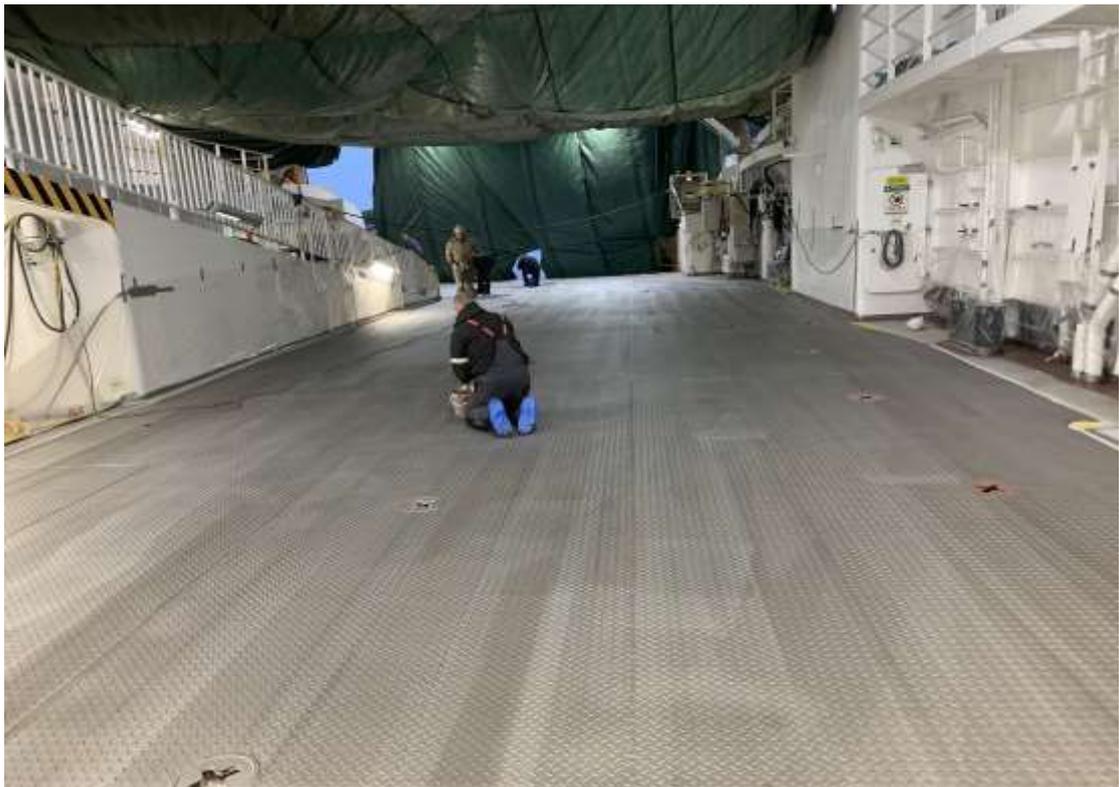
Generally, picture of achieved blasting standard

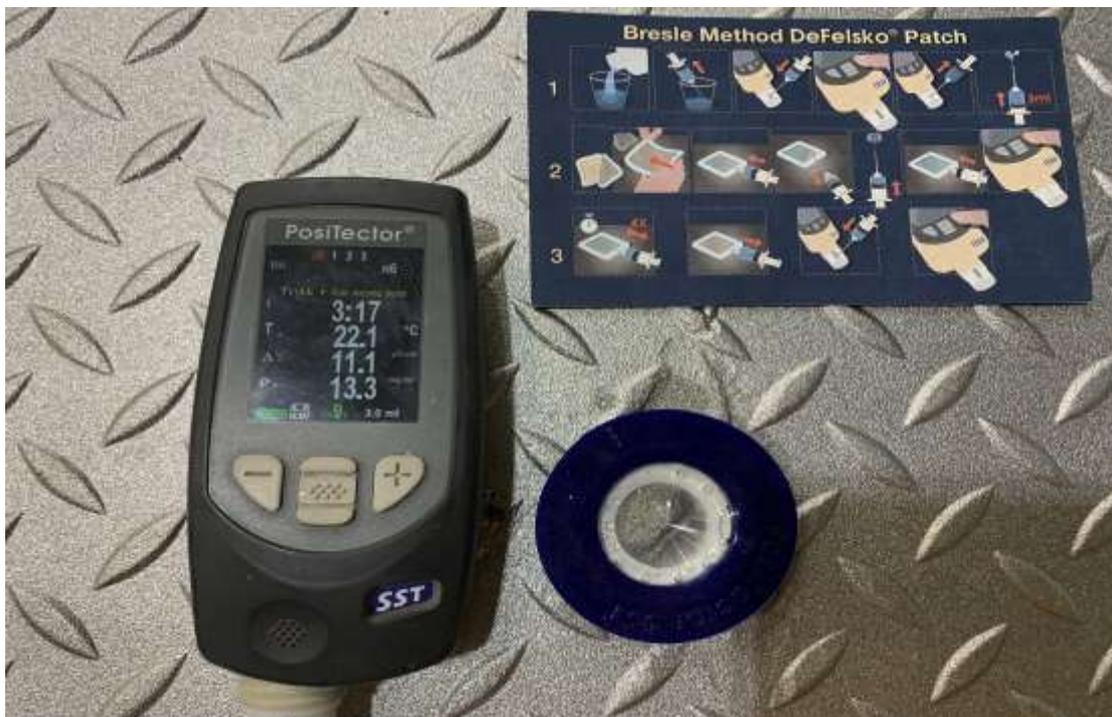
Bresle test results accepted 13,3mg/m<sup>2</sup>

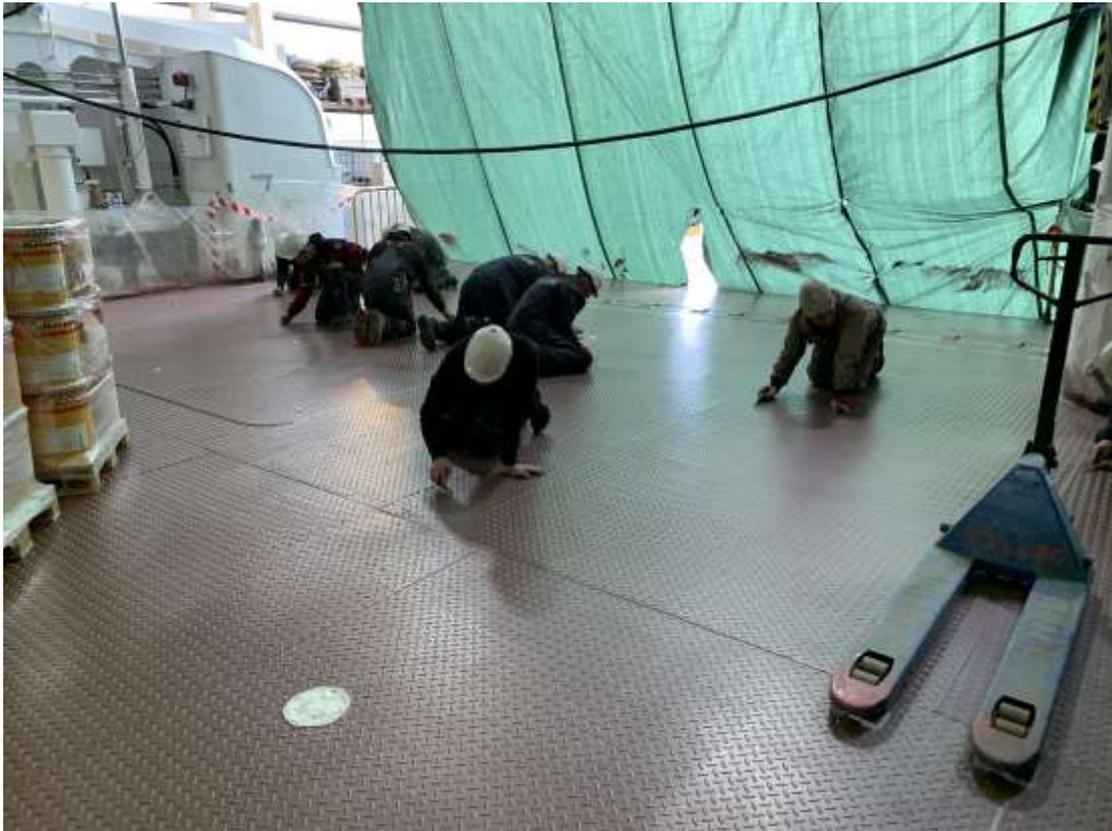
Cleaning /removal of minor locations with steel particles “abrasives from blast cleaning”.

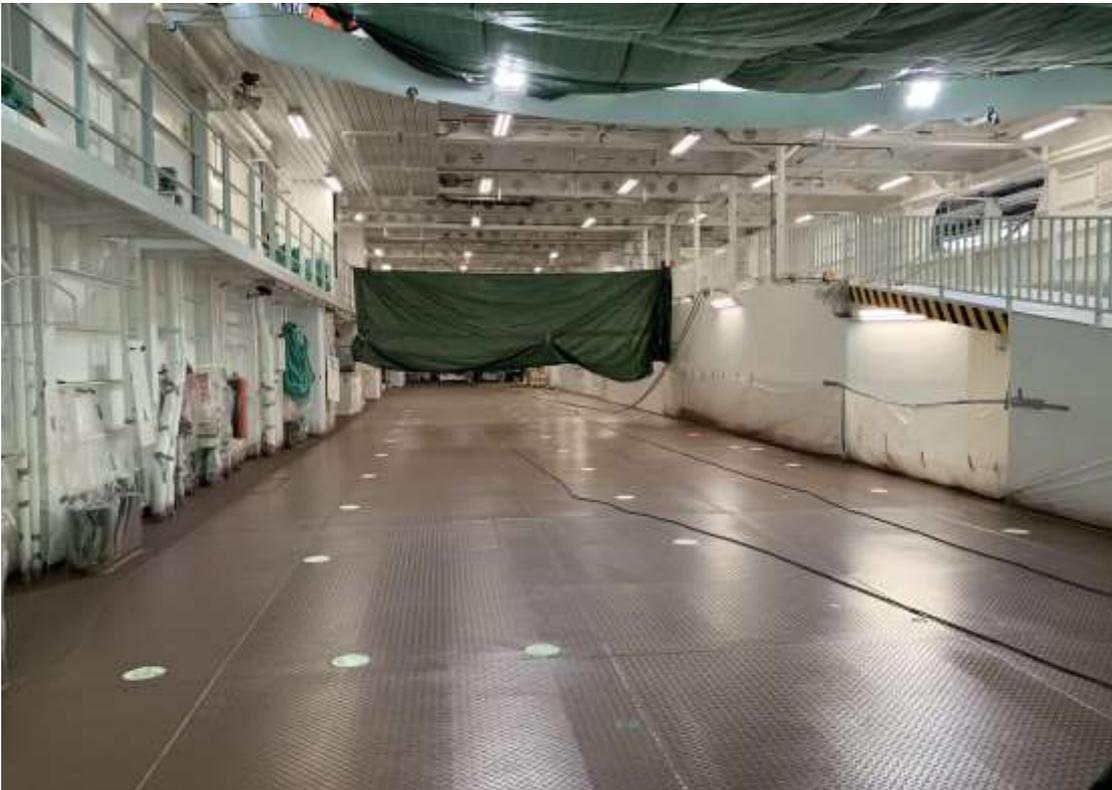
General picture after application Jotacote UNI N10 ATRT.

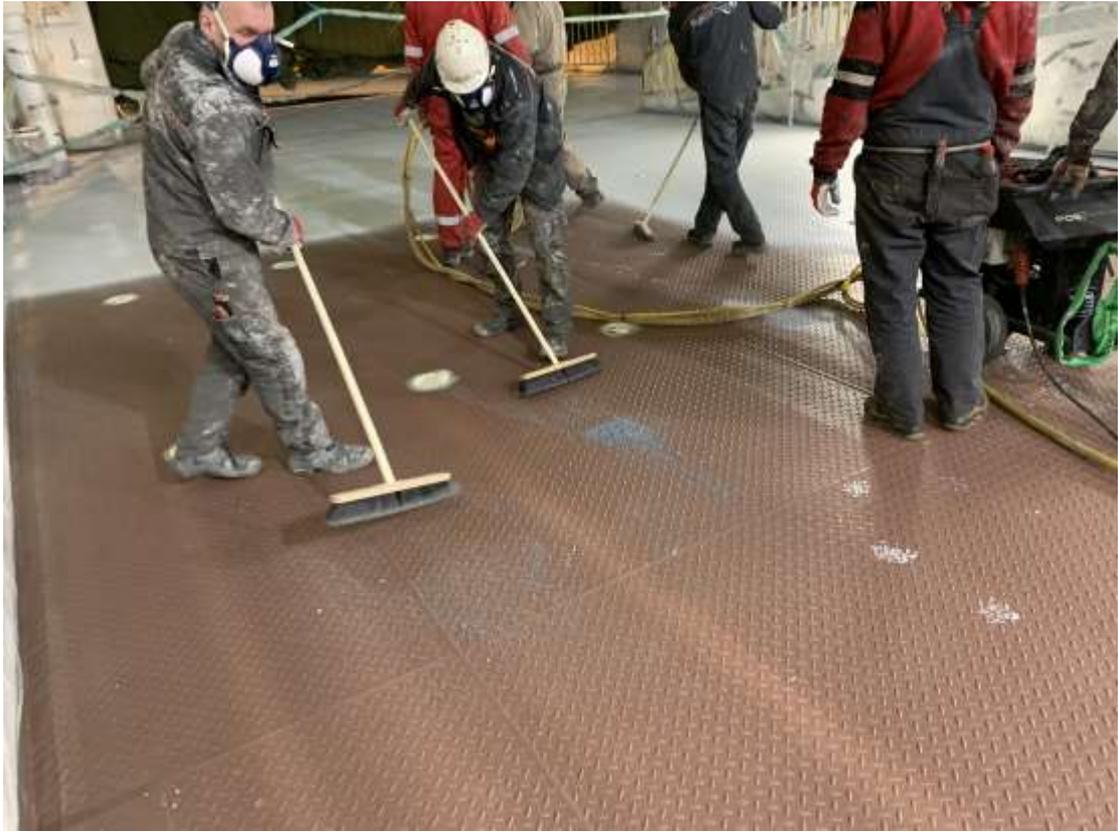
Cleaning of deck area during application Jota Armour.

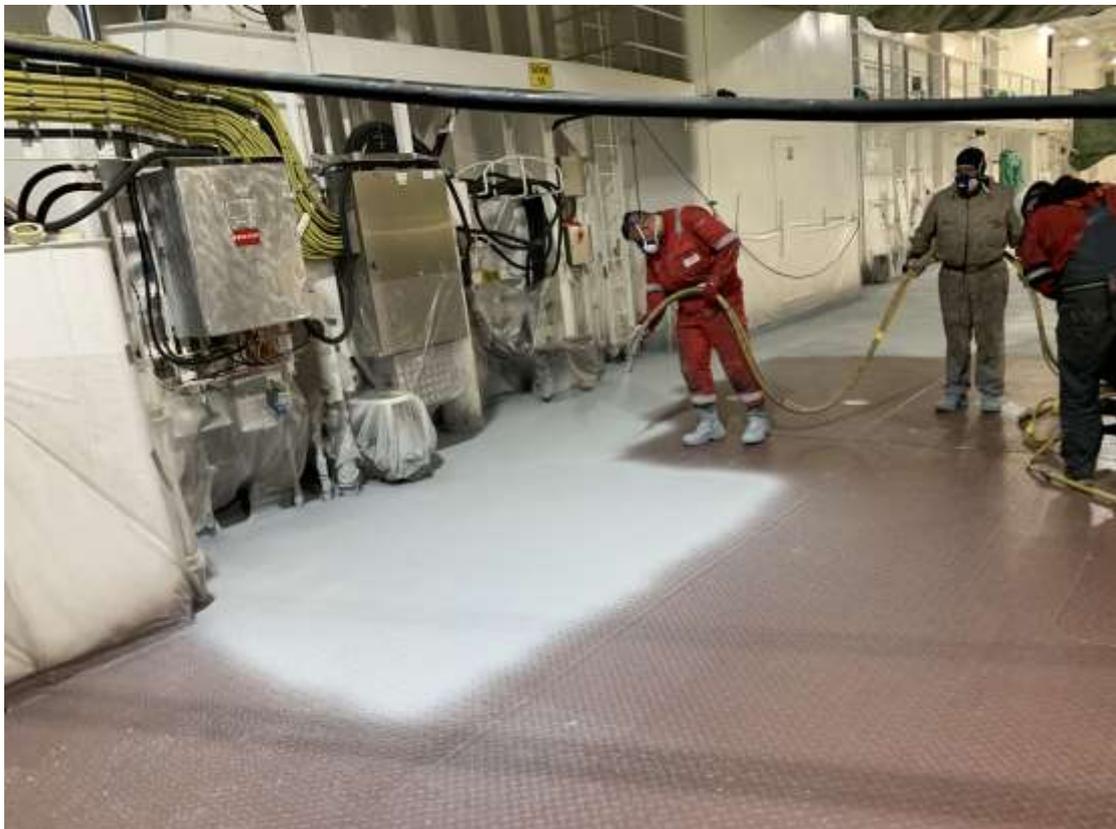
Application Jota Armour

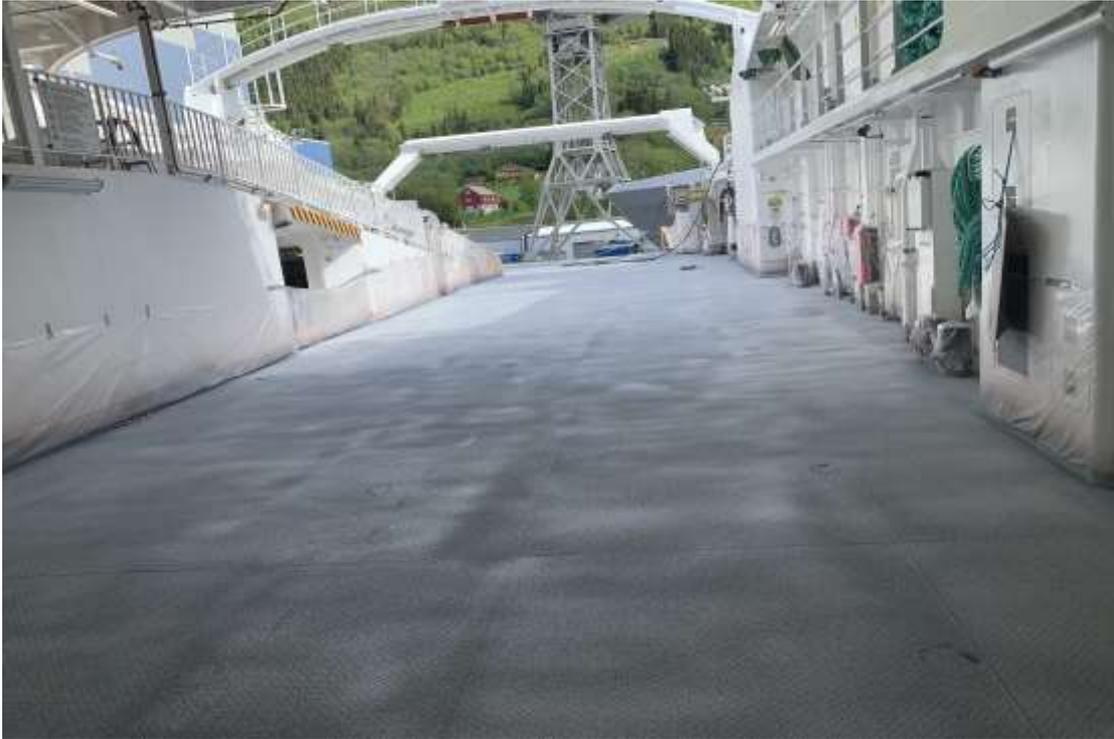
Application of Jota Armour completed.

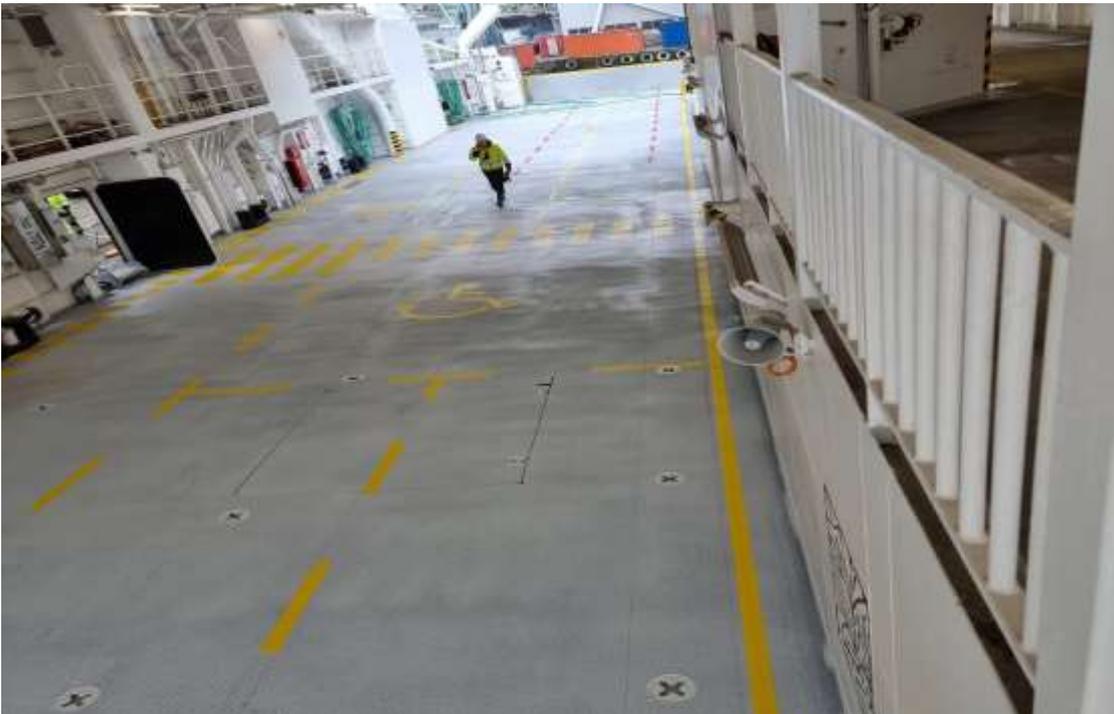
Marking of deck area finished.
