## «BF Utnefjord» VARD LANGSTEN

*Surface preparation and application report car deck area  
(application of Jotacote UNI N10 ALRT & Jota Armour 7035).*

**VISIT REPORT Maintenance and repair.**

<b>Ship</b> BF” UTNEFJORD”	<b>Shipyard:</b> VARD LANGSTEN	<b>Report No:</b> 01.	
<b>Owner:</b> Boreal Sjø	<b>Location:</b> Tomrefjord	<b>Page 1 of 7</b>	
<b>Area:</b> Car deck #56-0	<b>Contractor:</b> North Side A/S	<b>Date:</b> 21.05-25.05.22	
<b>Stage at time of visit:</b> Surface preparation/cleaning inspection		<b>Application:</b> Airless spray.	
<b>Product Name:</b>	<b>Coat No.:</b>	<b>Colour</b>	<b>D.F.T.</b>
Jotacote UNI N10	1	AL	200 microns
Jota Armour WG	2	Grey Ral 7035	1000 microns.
<b>NAME:</b>		<b>COMPANY:</b>	
Bjarte Bakken		VARD LANGSTEN AS	
Steinar Fitjar (Surface prep only).		Boreal Sjø A/S	
Mareno Ernes		JOTUN AS	
<b>REMARKS:</b>			
<p><u>Surface preparation</u>  <b>16.05.22 #56-#-56</b> High pressure water washing with detergent and steam water cleaning accepted to start further preparation.  <b>21.05.22 #56-#0</b>            Blast cleaning with airless blast cleaner machine to standard Sa 2,5 ISO 8501-1 are accepted except from:</p> <ul style="list-style-type: none"> <li

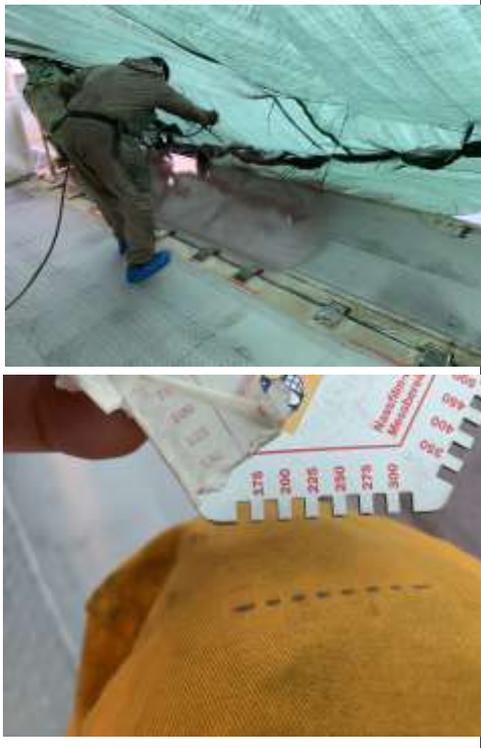
COAT NO.	1	2	Photos of application
Date / Time	21.05.22	24.05.22

Method	Airless blasting		
Surface Temp.	12,6c°	14,3c°	
Air Temp.	14,6c°	15,8c°	
Relative Humidity	71,1%	68,6%	
Dew Point	9,4c°	10,1c°	
Product Name	Jotacote Uni N10	Jota Armour	
Colour	ALRT	Grey Ral 7035	
Batch No. - Base	2779049-1-* -1:2	2767044-1-* -1:2	
Batch No. - Hardener	2758989-1-* -1:2	2770025-1-* -1:2	
Drying Temp./ Humidity	12c°	14c°	
Wet Film Thickness	Above 300 mic.		
Dry Film Thickness	122 readings mean average =307mic.	53 kit

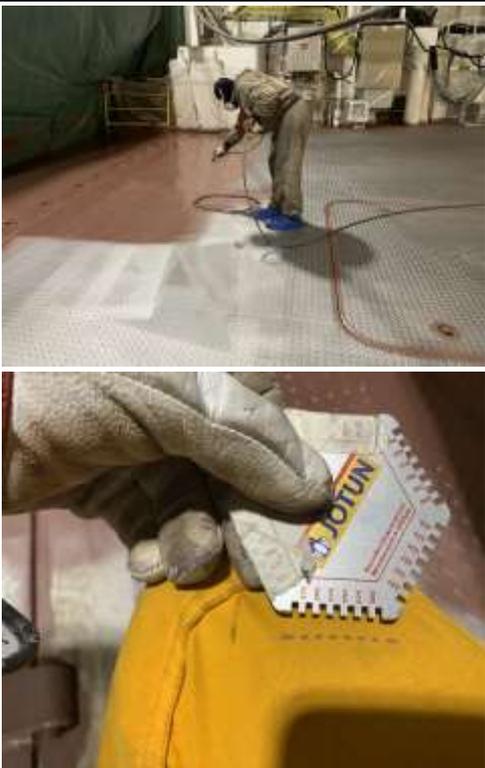
COAT NO.	1	2	Photos of application
Date / Time	23.05.22	24.05.22

Method	Airless blasting		
Surface Temp.	16,6c°	13,7c°	
Air Temp.	15,6c°	15,0c°	
Relative Humidity	65,0%	70,1%	
Dew Point	9,0c°	9,6c°	
Product Name	Jotacote Uni N10	Jota Armour	
Colour	ALRT	Ral 7035	
Batch No. - Base	2779049-1-*-1:2	2767044-1-*-1:2	
Batch No. - Hardener	2758989-1-*-1:2	2770025-1-*-1:2	
Drying Temp./ Humidity	15c°	12c°	
Wet Film Thickness	Above 300 mic.		
Dry Film Thickness	122 readings mean average =307mic.	53 kit
